Responding to Reoccurring Coliform Detects South Shore Water System South Kingstown, RI

NEWWA Spring Conference & Exposition DCU Center, Worcester, MA April 1, 2015

Kristen Berger, P.E.
Comprehensive Environmental Inc.

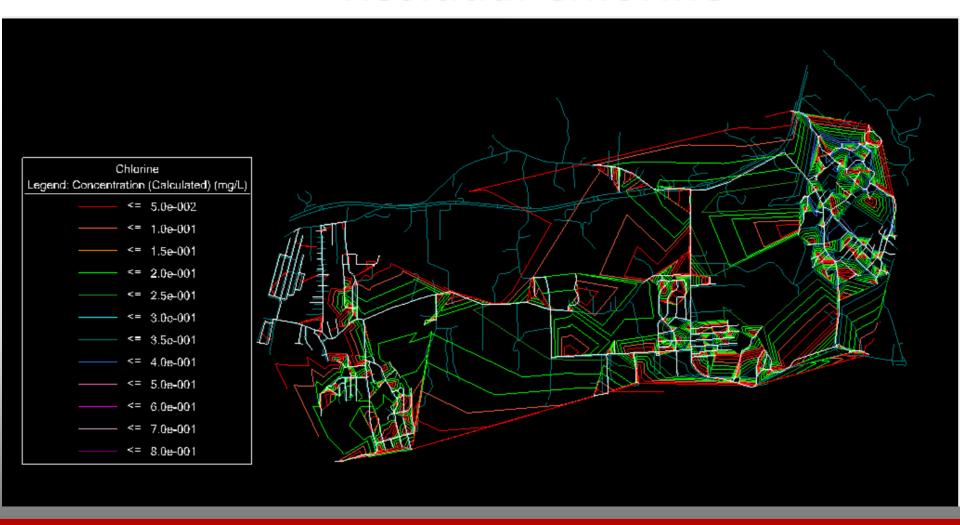
Existing Conditions/Operations Residual Chlorine

- Chlorinated water supplied by UWRI
- Town monitors twice monthly at several locations
- Level at interconnection typically
 0.3-0.5 mg/L, but can be < 0.1 mg/L
- Levels at TC sampling sites typically trace amounts
- Levels at Mautucket Road Tank site
 0.0 to 0.05 mg/L Essentially Non-Detect

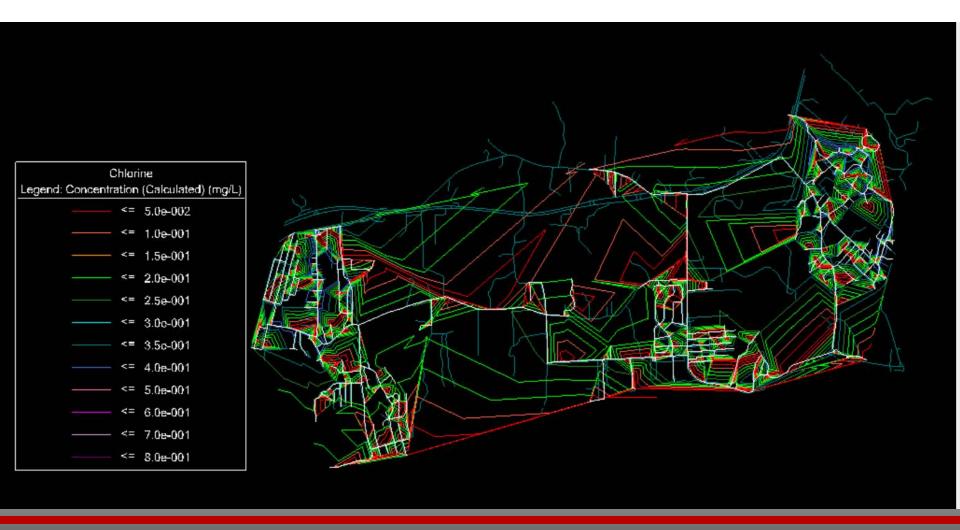
Chlorine Addition at Mautucket Road Tank

- Hourly Changing Average Day Demand
- Assumes 0.4 mg/L residual chlorine provided at interconnection and another 0.4 mg/L added as water flows out of Mautucket Road Tank
- Over two weeks shown, residual chlorine remains close to 0.4 mg/L in the areas around Mautucket Road Tank. This is an improvement over existing conditions.
- No areas of the system are greater than
 0.4 mg/L chlorine

- Chlorination station to be constructed at Mautucket Road Tank
 - Design currently under review by RI Dept. of Health
 - Generally consists of precast concrete building, metering pump, day tank, chlorine analyzer, flow meter and SCADA upgrades
- Considering tank mixing system

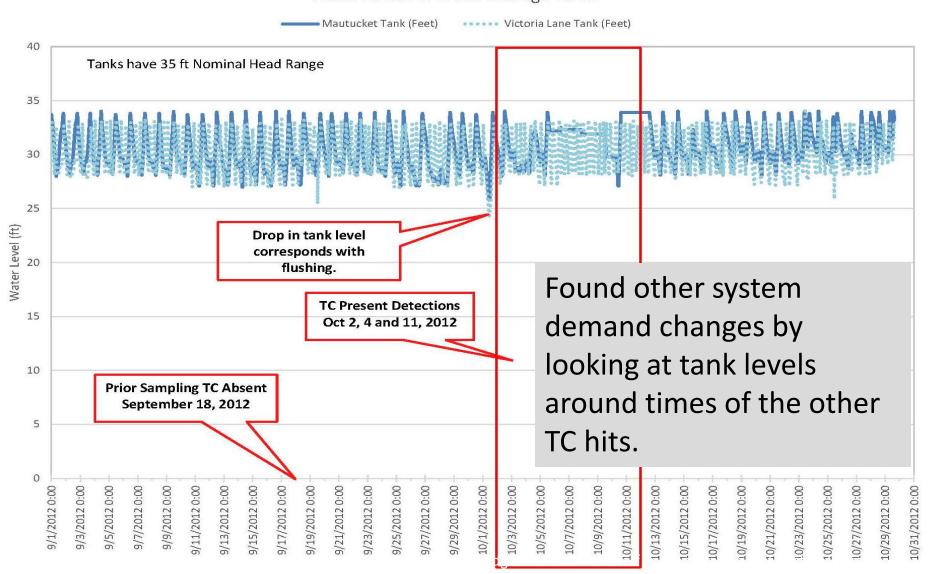
Tank Levels: Sep – Oct 2012

- System operations that can cause disruptions
 - Main breaks
 - Main construction
 - Power losses
 - Pressure losses
 - Source water changes
 - Flushing and Changes in flow patterns
 - Flushing and/or tank level change did occur prior to detects
