# Watershed Management and Modeling as Tools in the Restoration of Pearly Pond, Rindge NH

Catherine Owen Koning Franklin Pierce University, Rindge, NH Rebecca Balke, Ben Lundsted

# Pearly Pond Management Planning Project

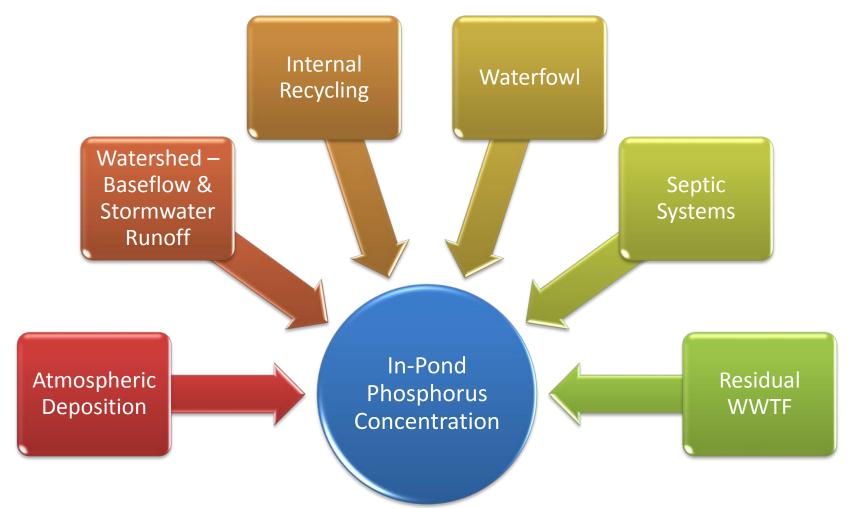
- ENSR-LRM Model Land-use export coefficient model
- Land use, septic system data collected via surveys, ground-truthing, landowner contact
- Inputs predict phosphorus load, water load, and phosphorus concentrations in streams and pond
- Calibrated to 2009-2014 water quality data
- 2009 marks end of WWTF discharge to wetlands redirected to rapid infiltration basins (RIBs)

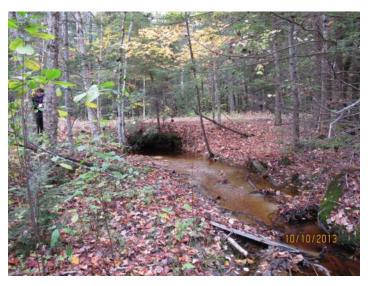
**Bank Erosion**

### **Potential BMP Sites – Culverts & Stream restoration**

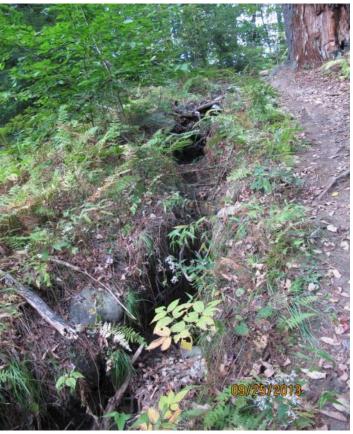
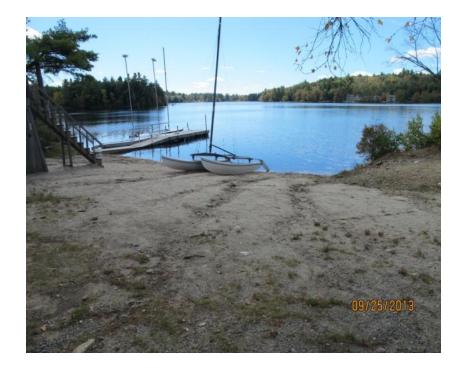
### **Potential BMP Sites – Erosion Repairs**

#### **At Drainage Outfalls**

#### **Along Shoreline**

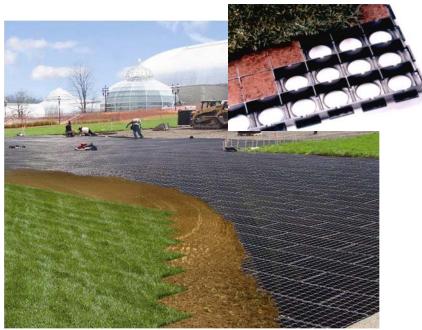
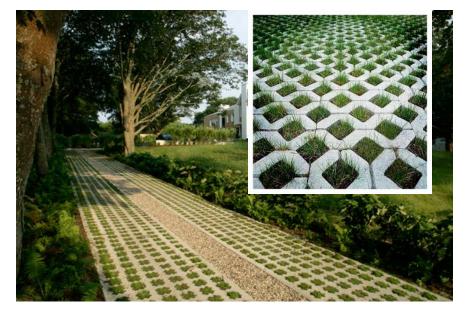
### **Beach Areas & Access Points – Site Stabilization**

& Porous Materials
