Broad Meadow Brook Restoration: Achieving Ecological Outcomes in an Urban Headwaters

Project Team: Tom Lautzenheiser (MAS), Martha Gach (MAS), Dave Harris (City), Kate Bentsen (DER), Stefanie Covino (BWC)

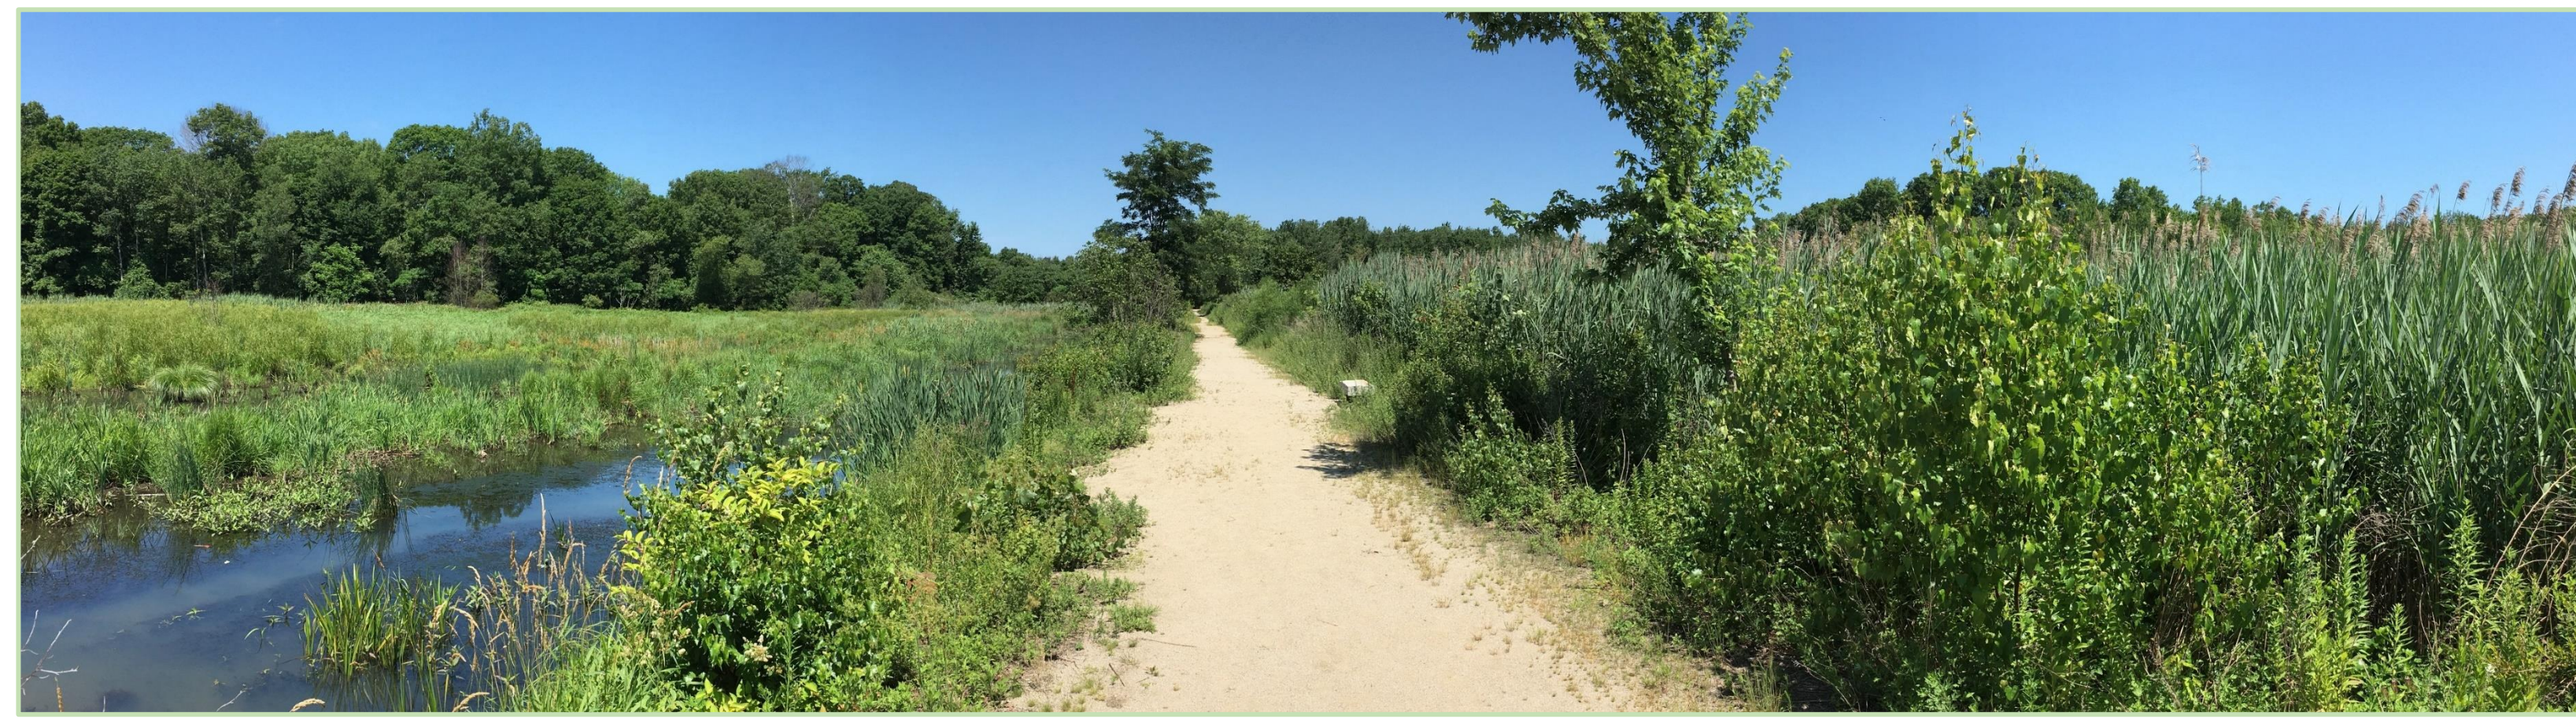
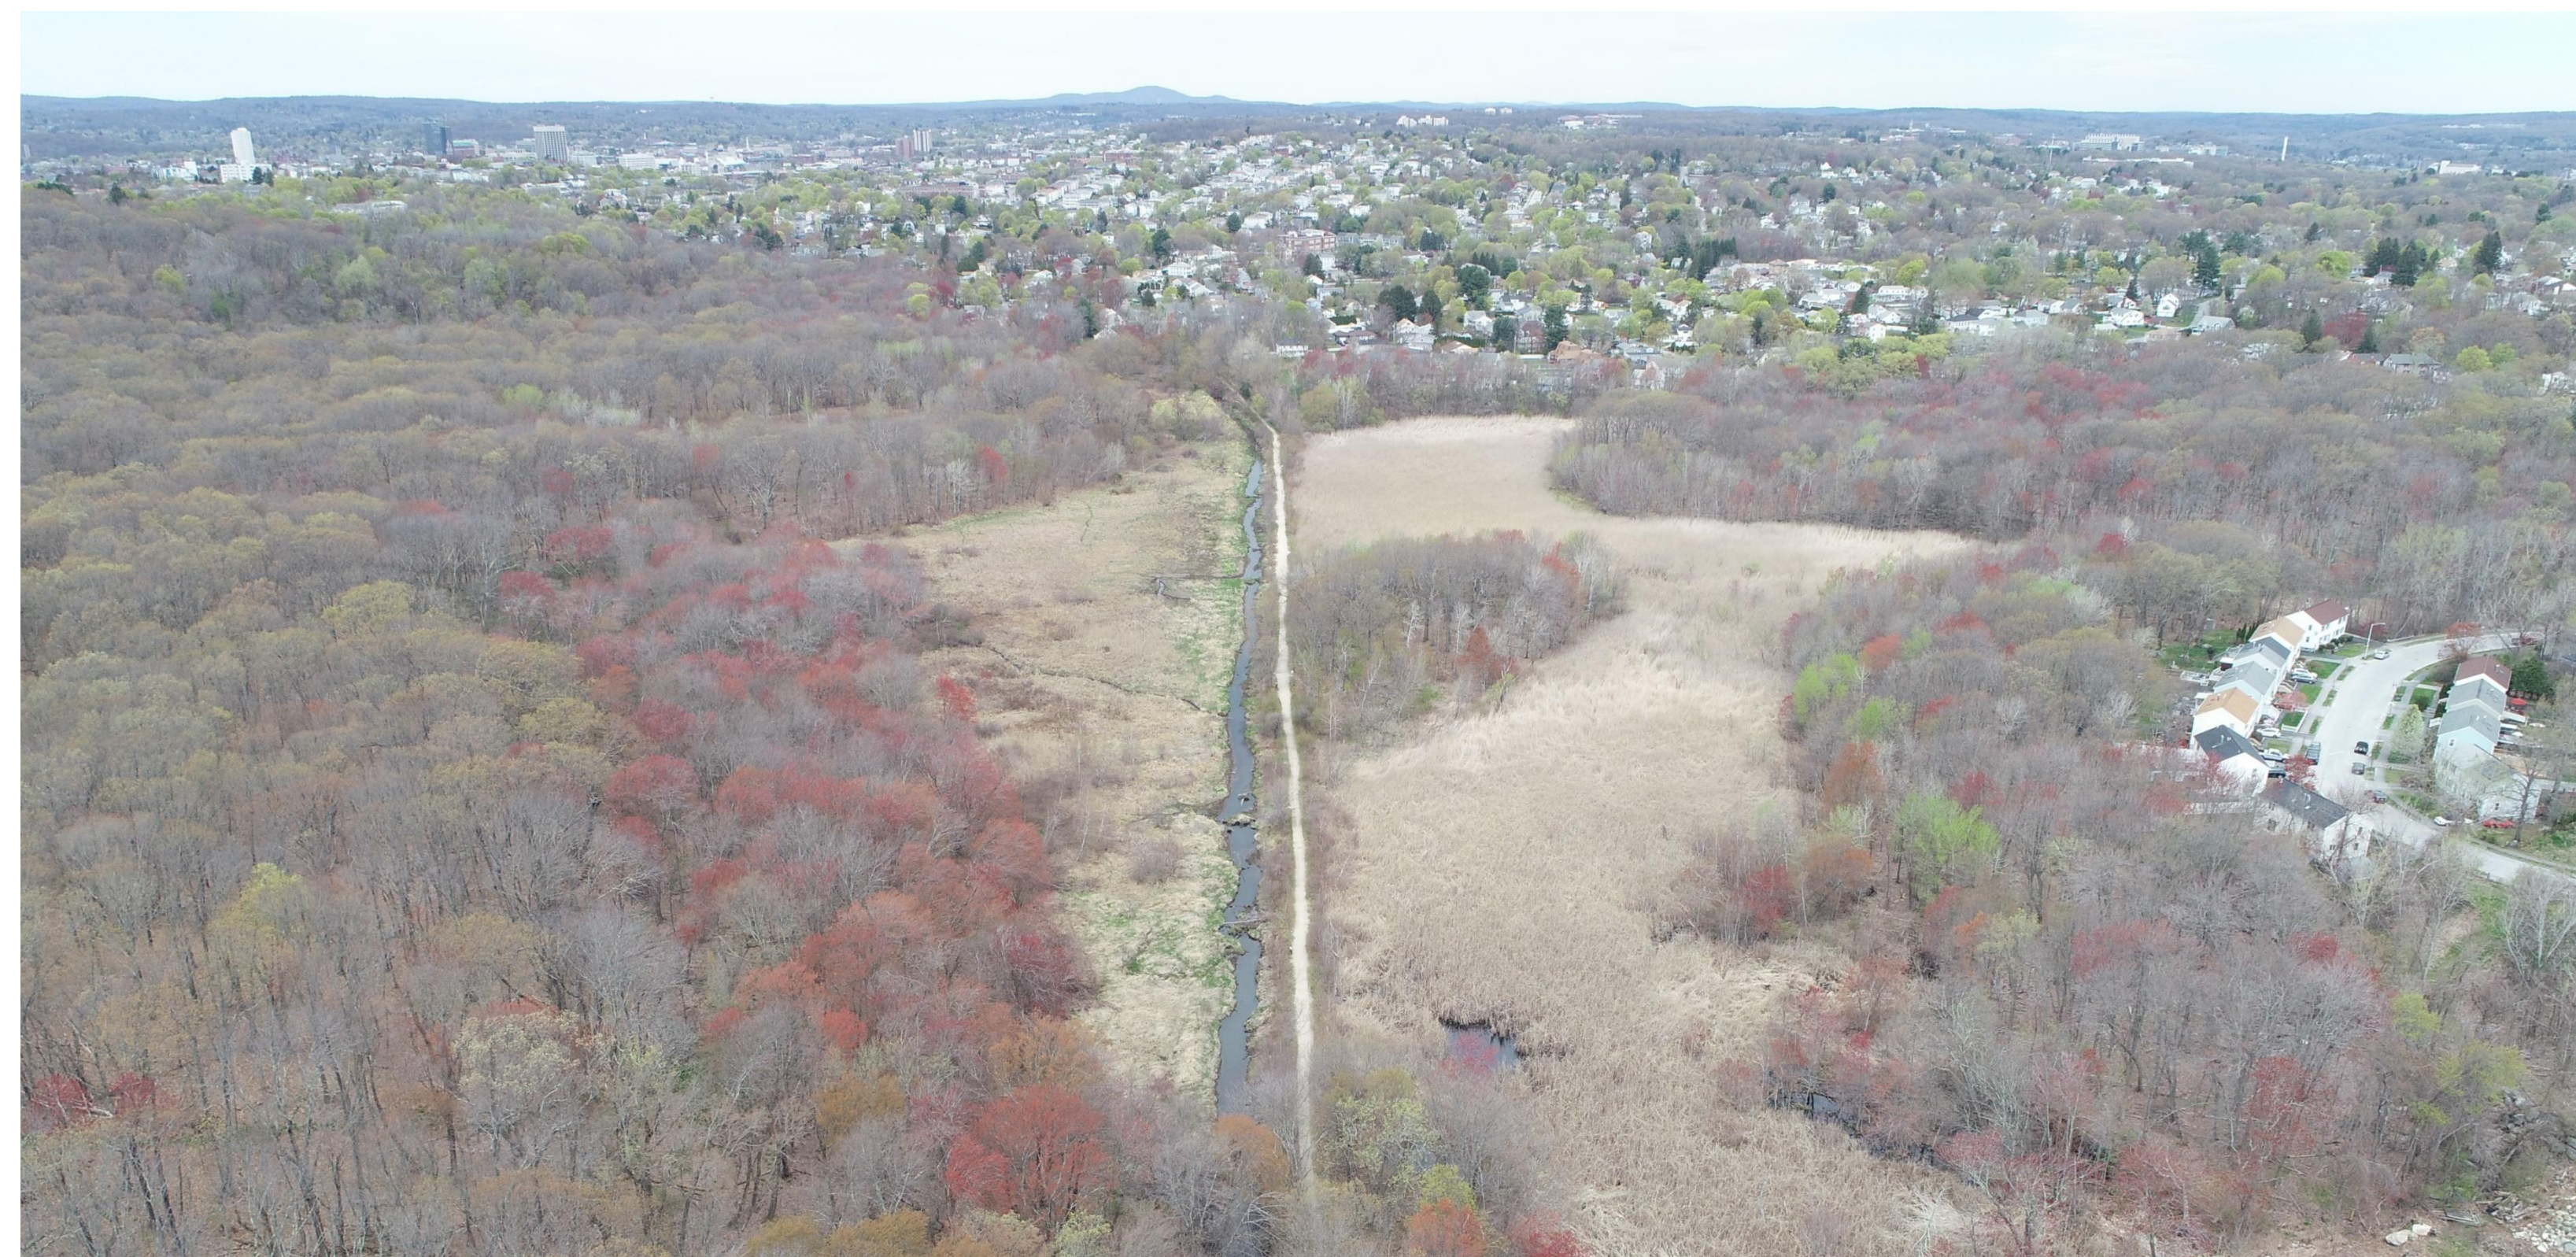
Ground view (top) and aerial view (bottom) showing intact wetland on left; channelized brook and causeway in center; and *Phragmites*-dominated wetland on right.

- Adjacent neighborhood, including Environmental Justice communities, subject to flooding
- Earthen berm causeway built to house decommissioned municipal sewer main disrupts hydrological connection
- Wetland complex dominated by invasive *Phragmites*
- Brook piped through buried culvert prevents riparian connection and stream habitat

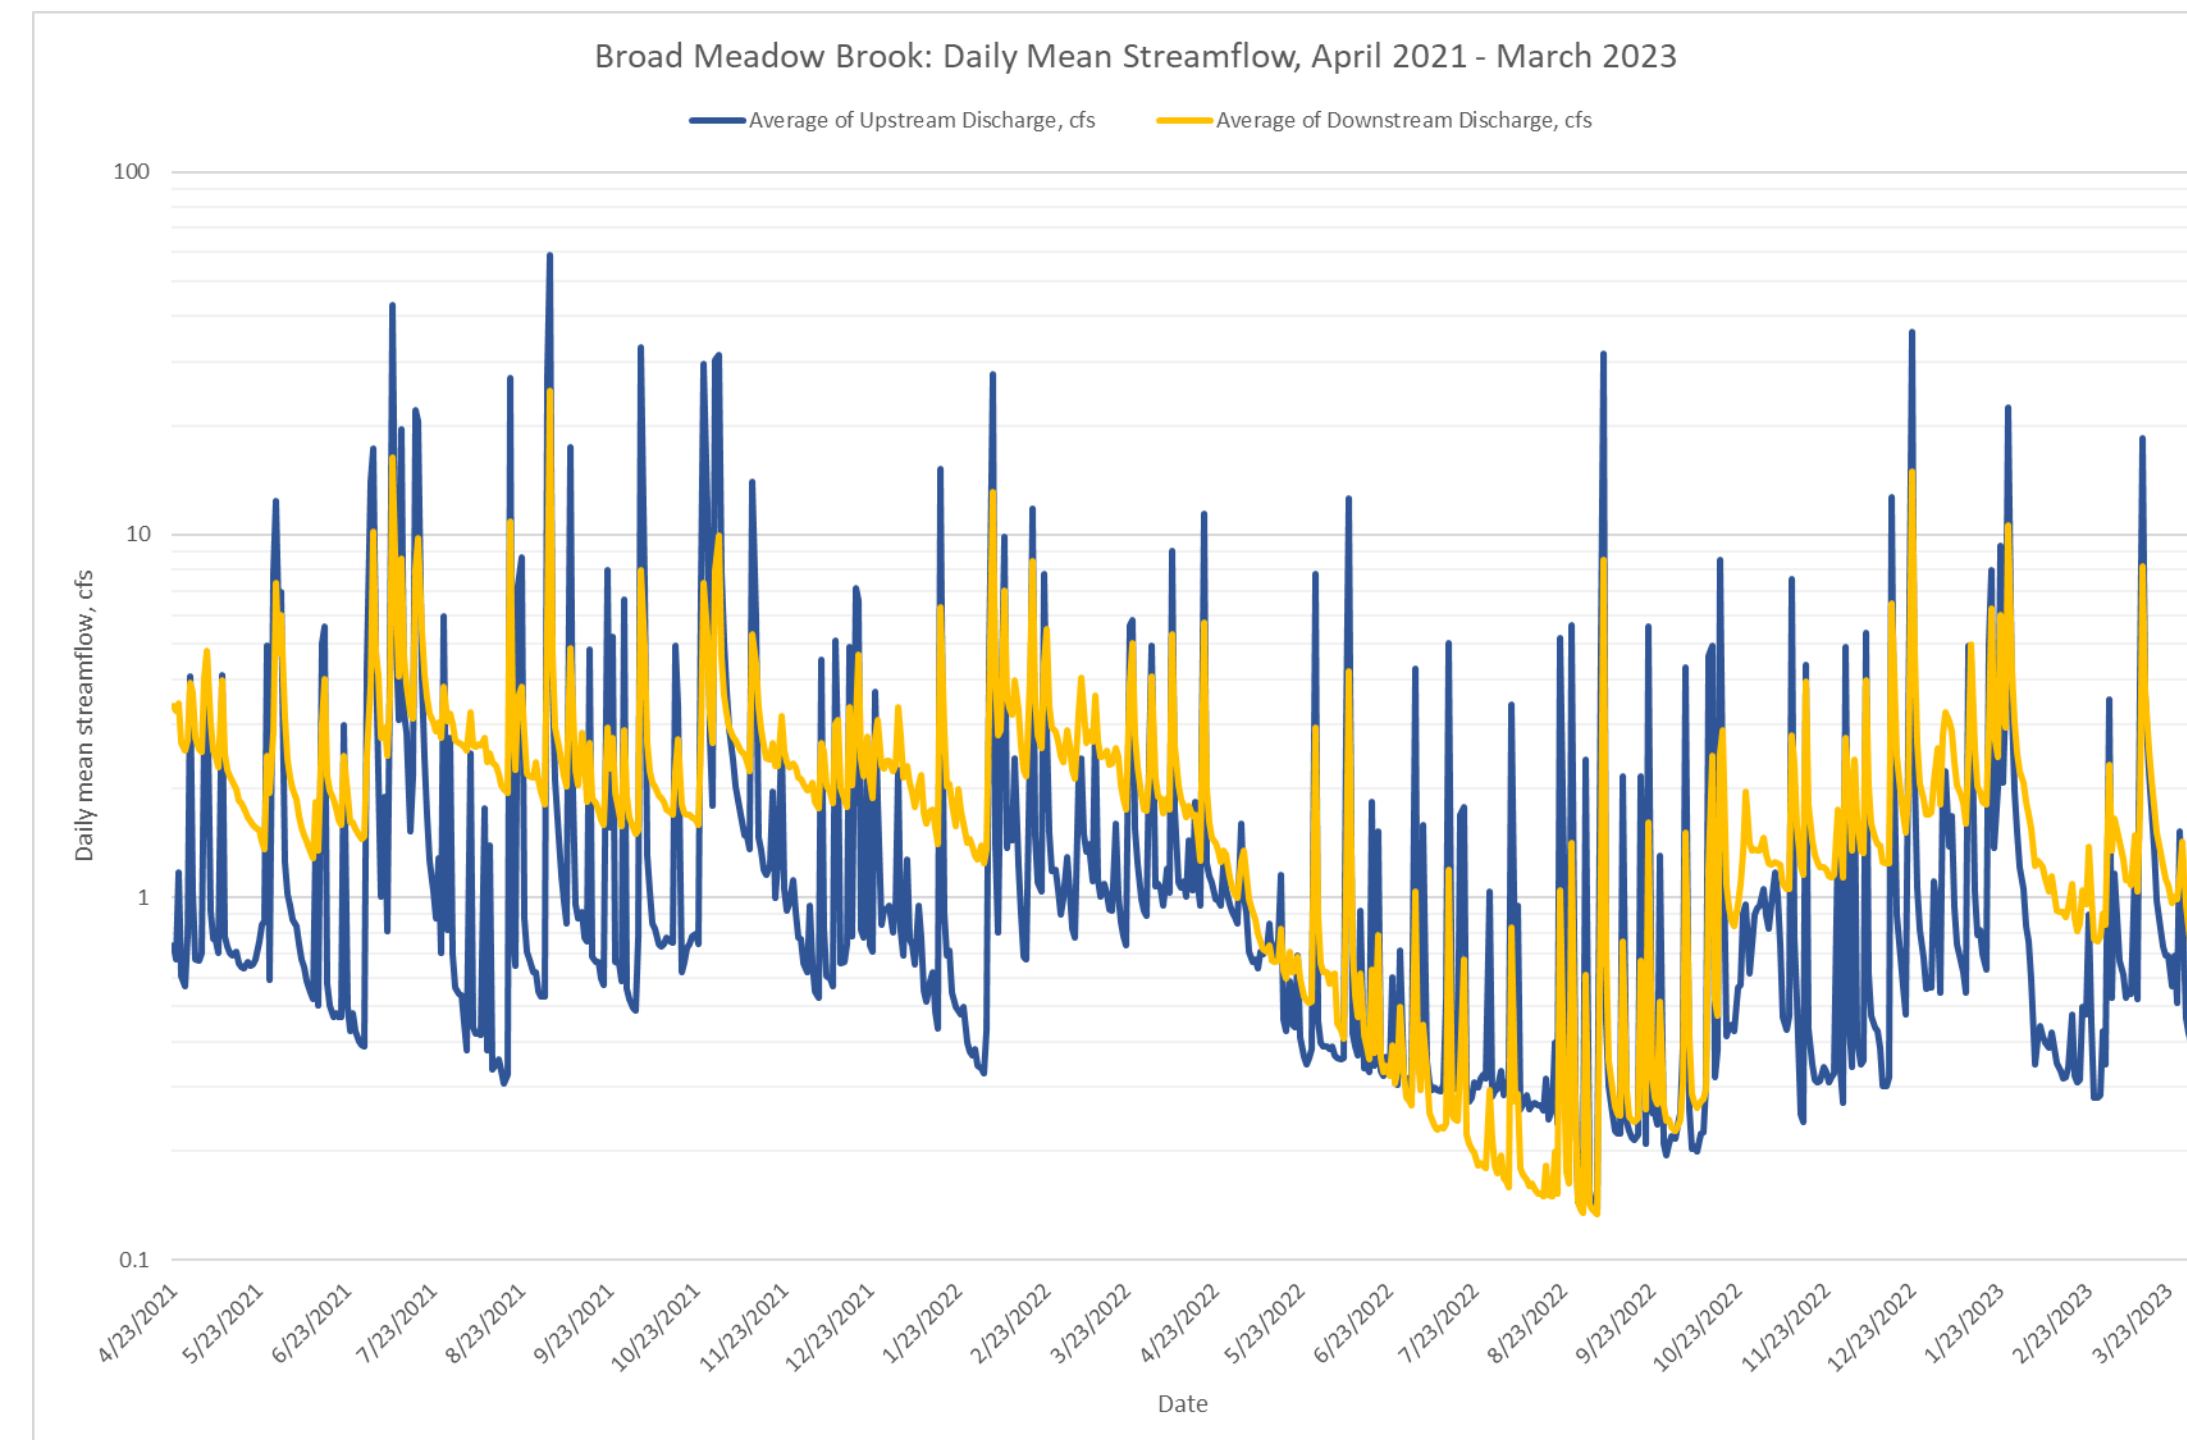
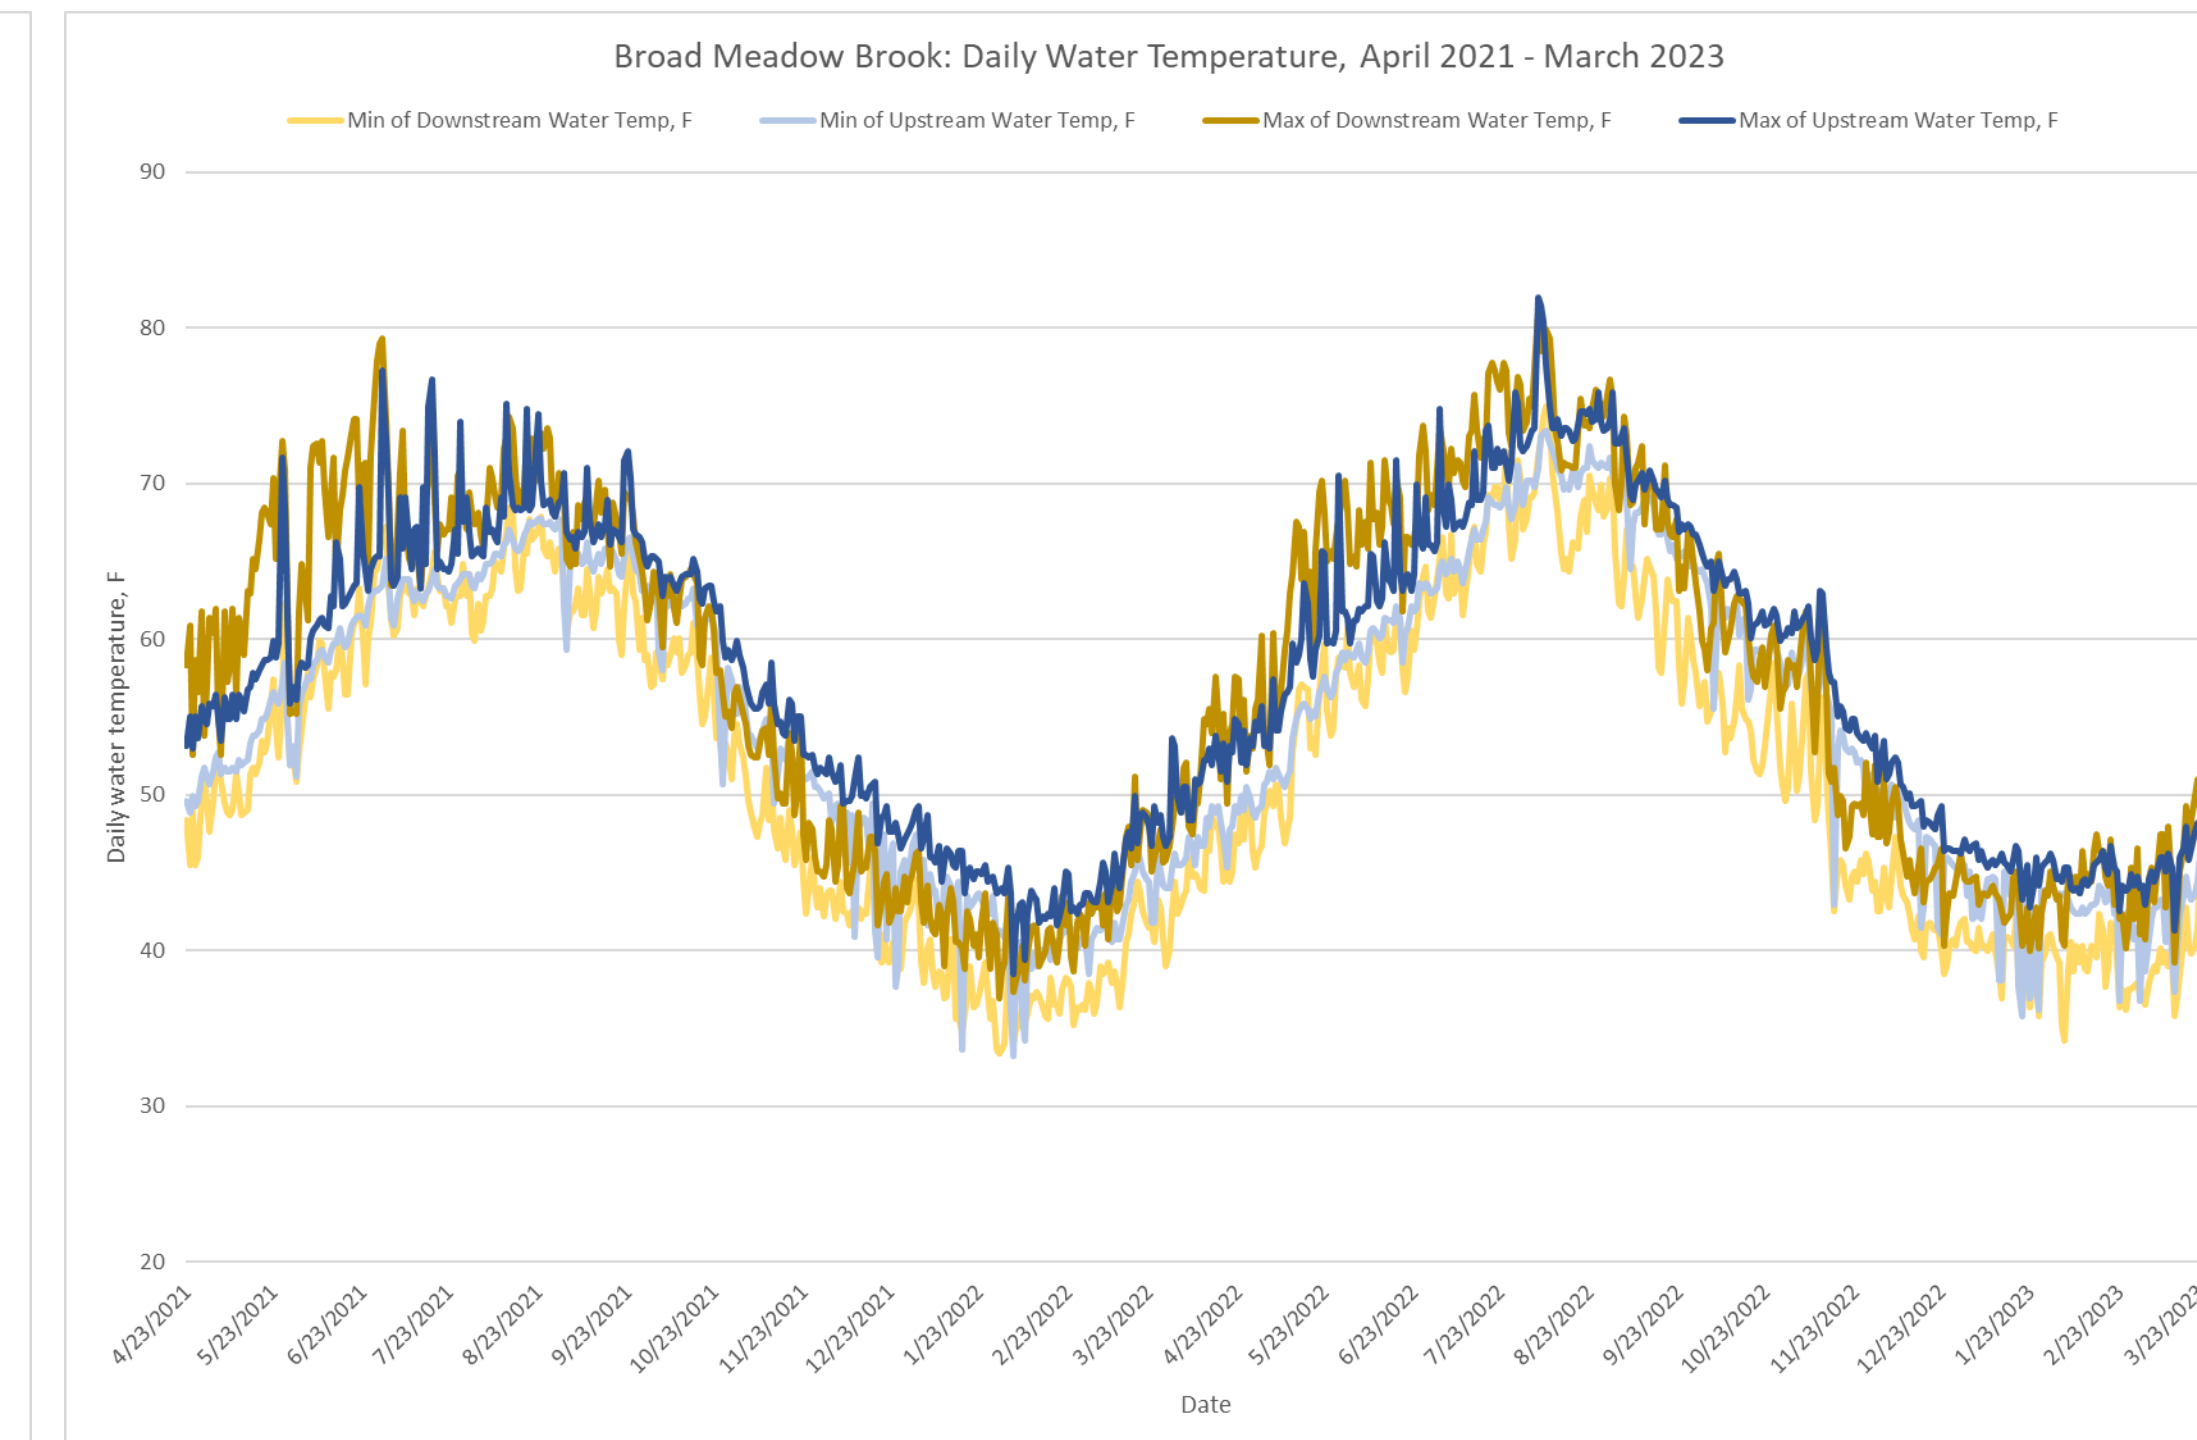
Continuous streamflow and water temperature data collected at gaging stations established along Broad Meadow Brook at the inflow to and outflow from the proposed restoration area. Streamflow data show flashy hydrology highly driven by stormwater inputs after rainfall events. Warm water within the Brook frequently exceeds thermal tolerances for most freshwater fish and invertebrates.

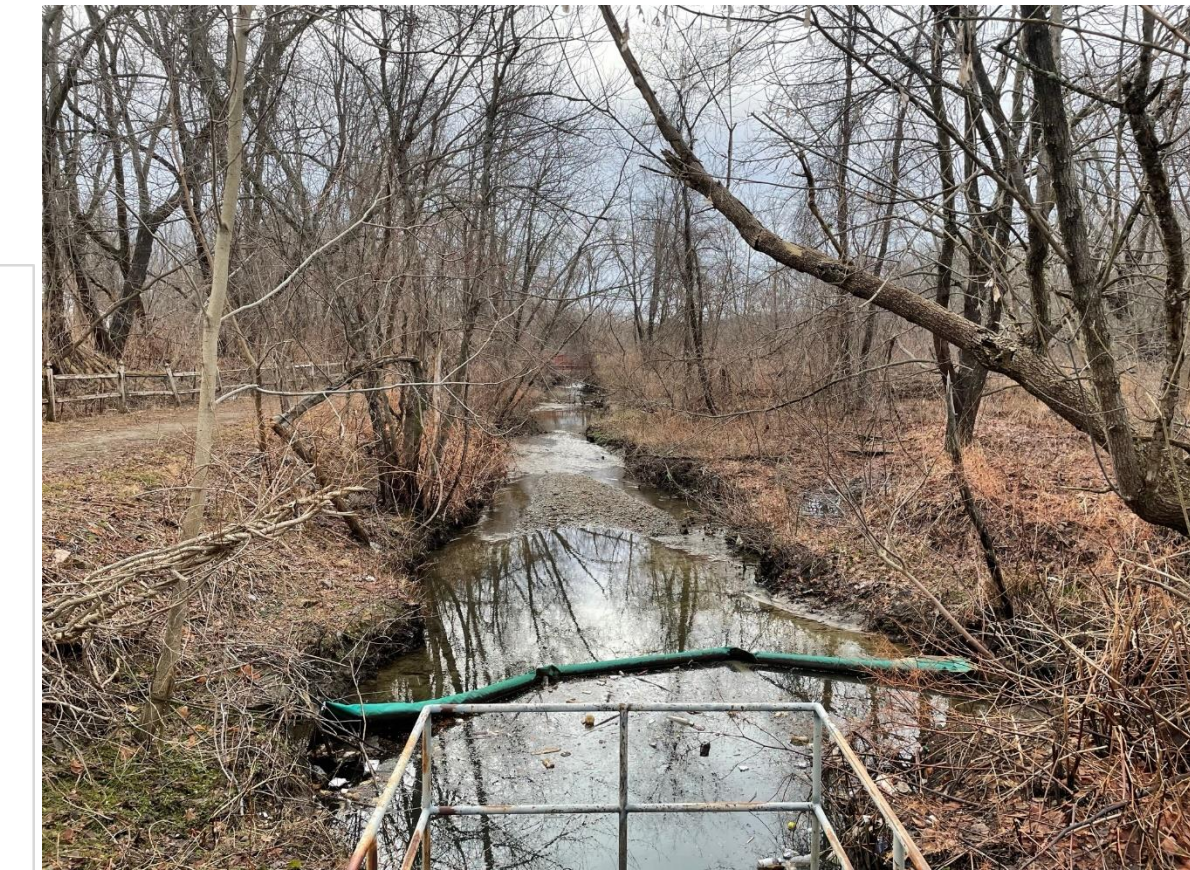
Inflow from stormwater system

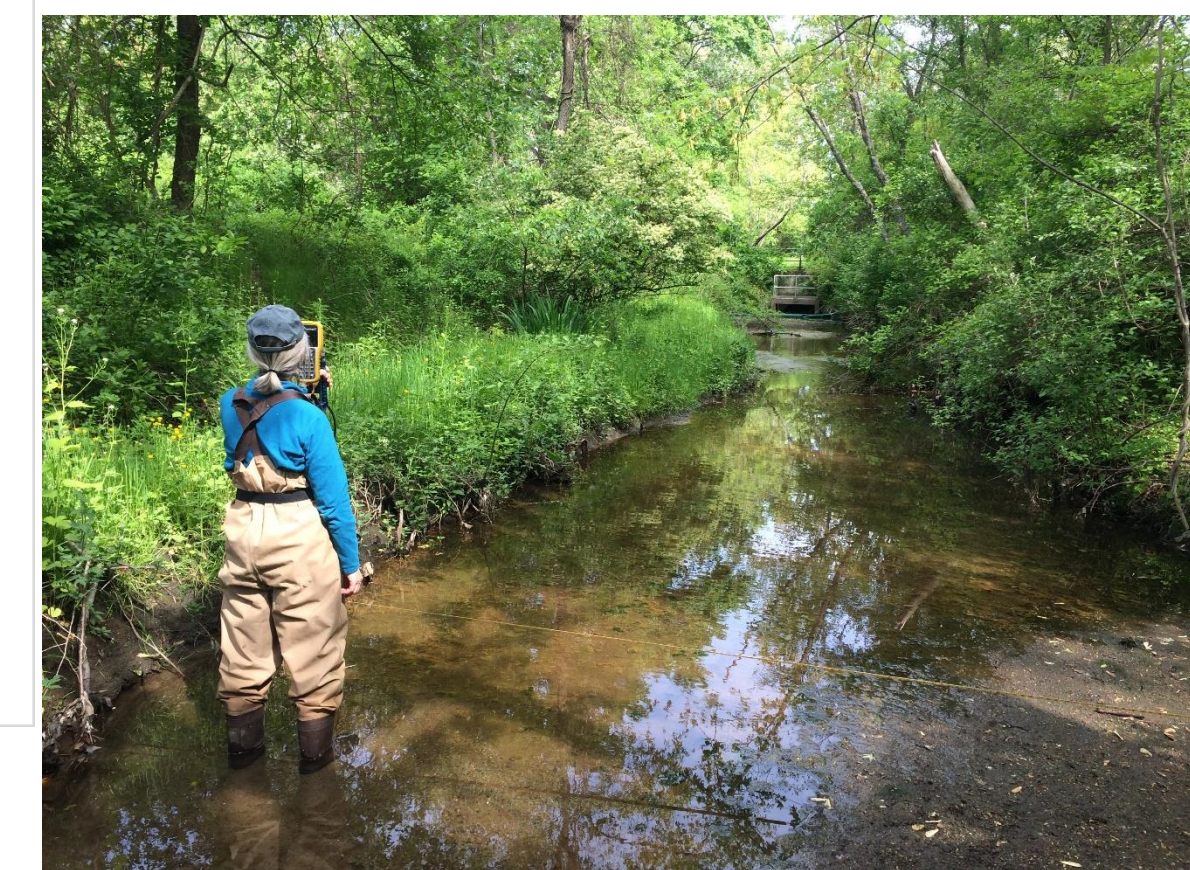
DER staff measure streamflow

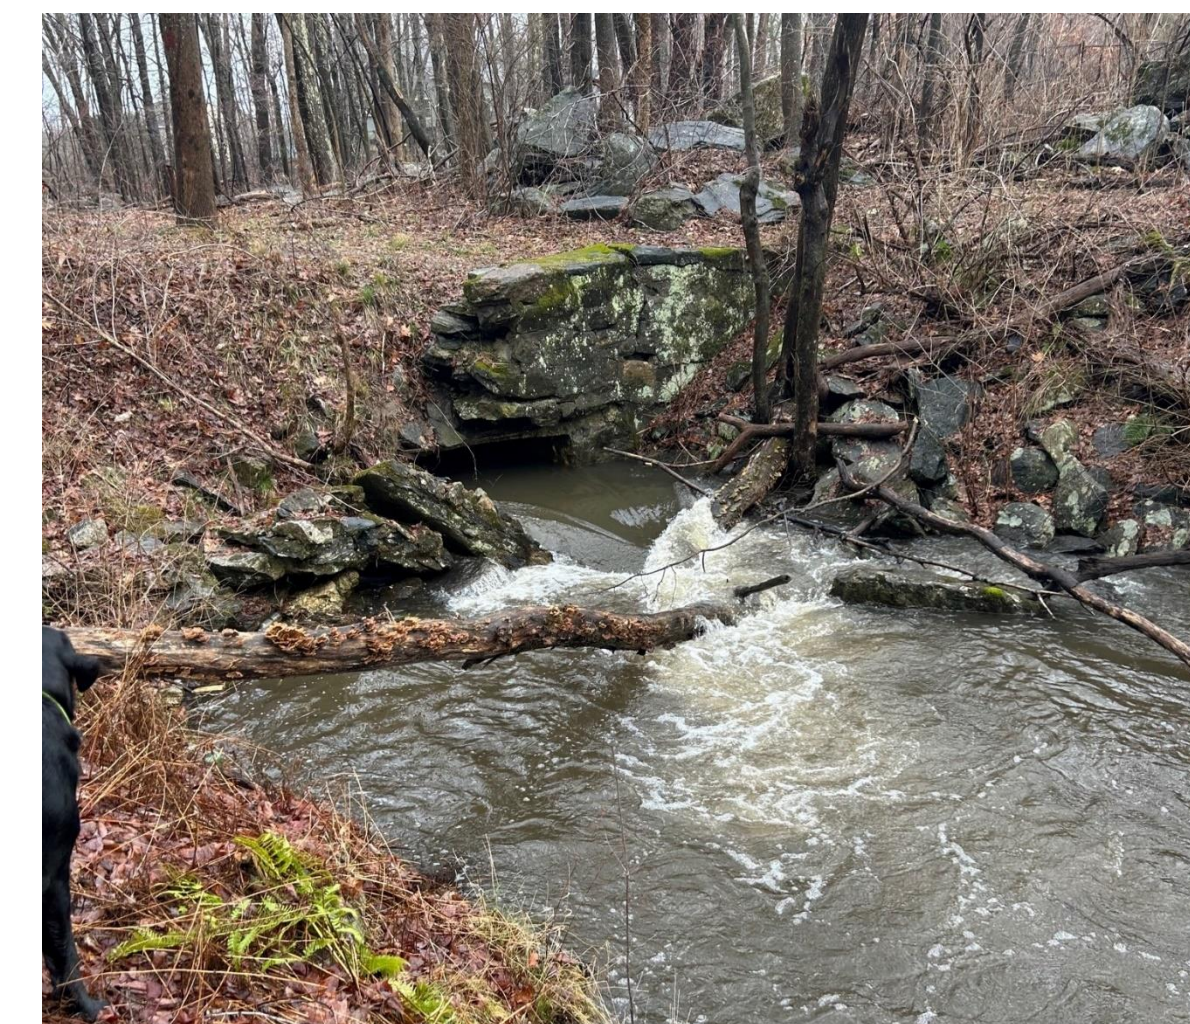
Flood event in December 2021

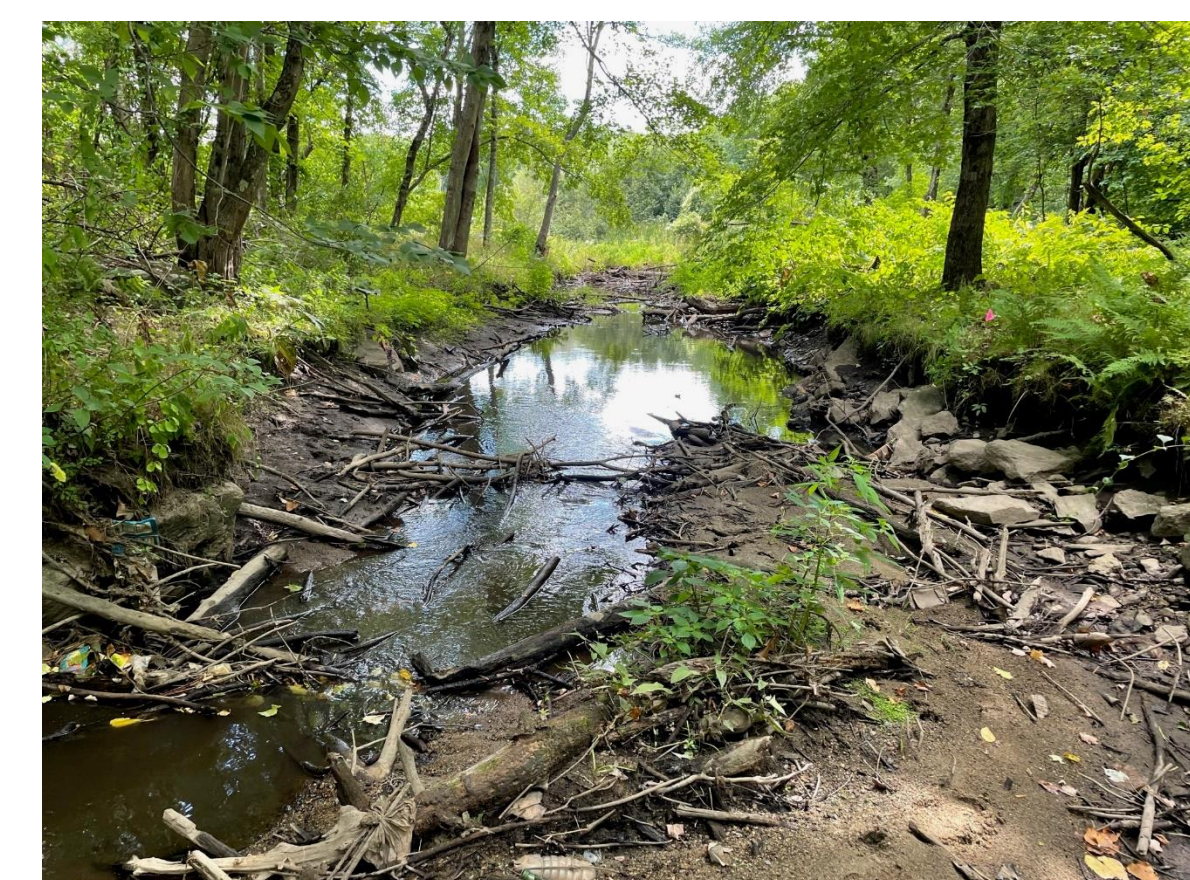
Drought conditions in August 2022
