Investigation and Ecological Risk Assessment of Atlantic Shellfish Site

By Group 4: Samantha Mazur, Fernanda Mastroluca, Ally Huffman, Akanksha Patel, and Leila Shwayhat

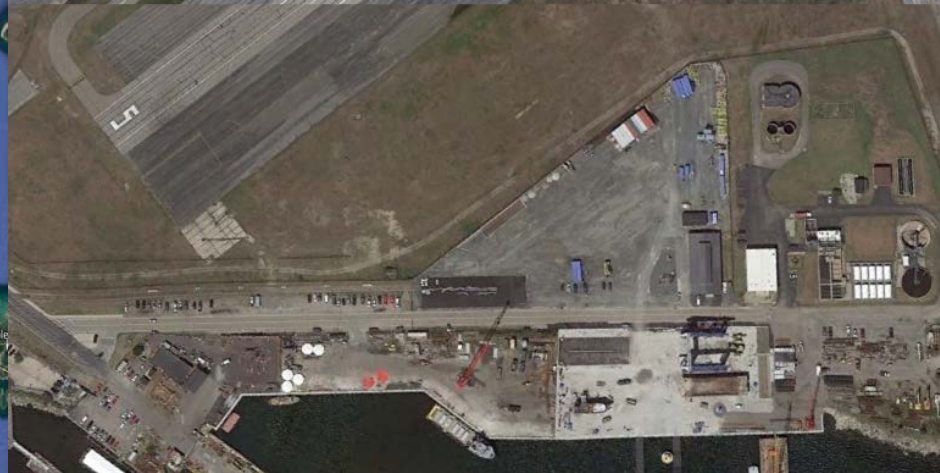
Figure 2 – Site Map
Atlantic Shellfish HTRW Site
Quonset Point NAS
North Kingstown, Rhode Island

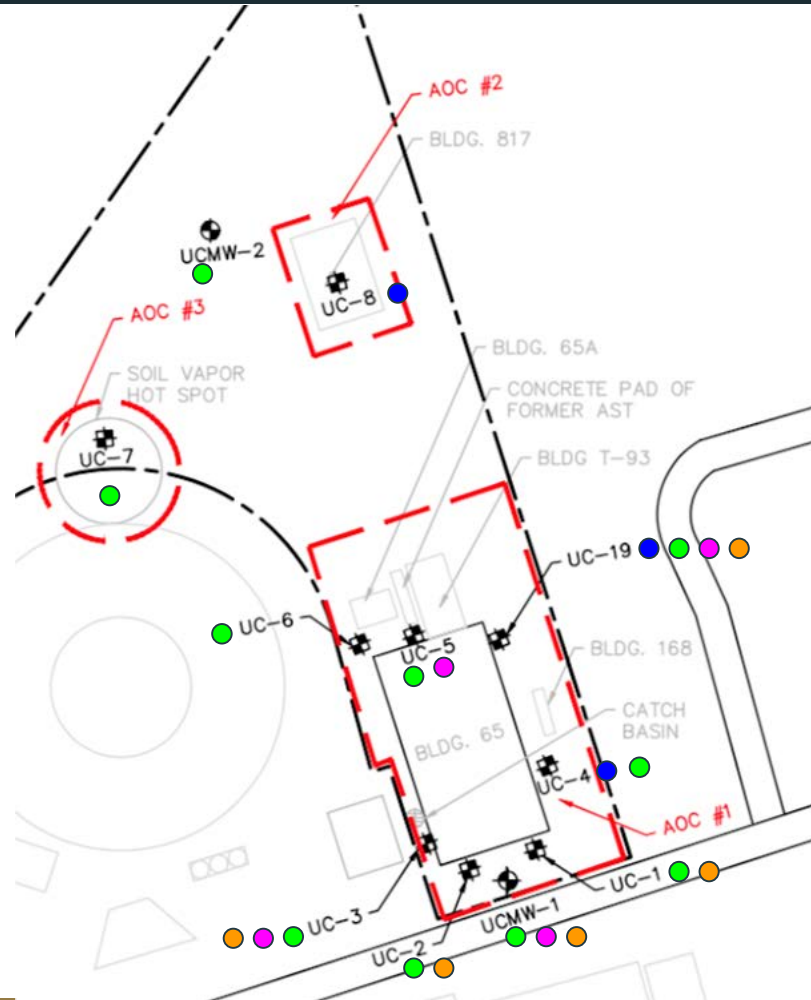
Sampling Locations North

- Blue: PCB
- Green: VOCs and chlorinated solvents
- Pink: TPH
- Orange: RCRA Metals
- ⊕ UC - Soil Boring
- ⊞ UCMW - Monitoring Well

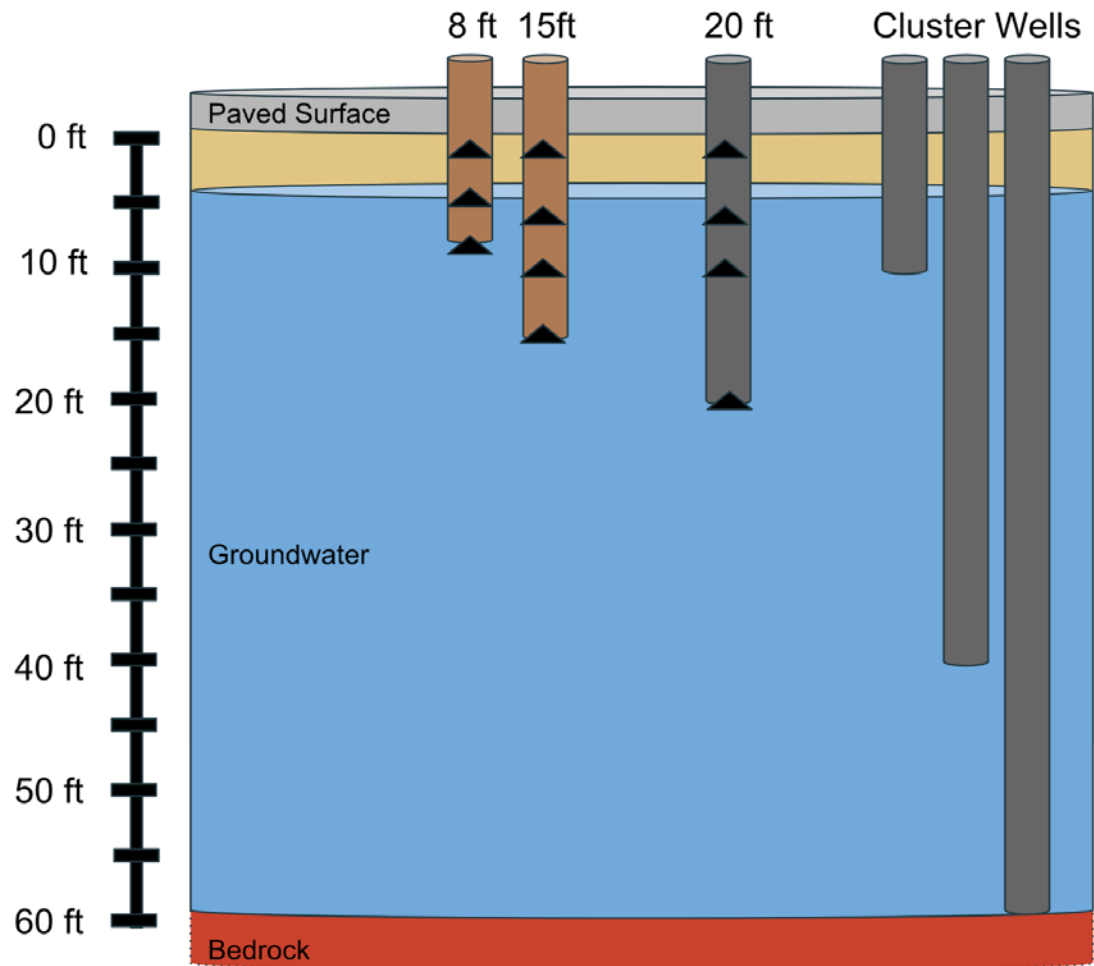
Sampling Locations South

Sampling Depths (ft):
8: 3, 6, 8
15: 3, 7, 11, 15
20: 3, 7, 11, 20
Cluster wells (10 ft. 40
ft, and bedrock)

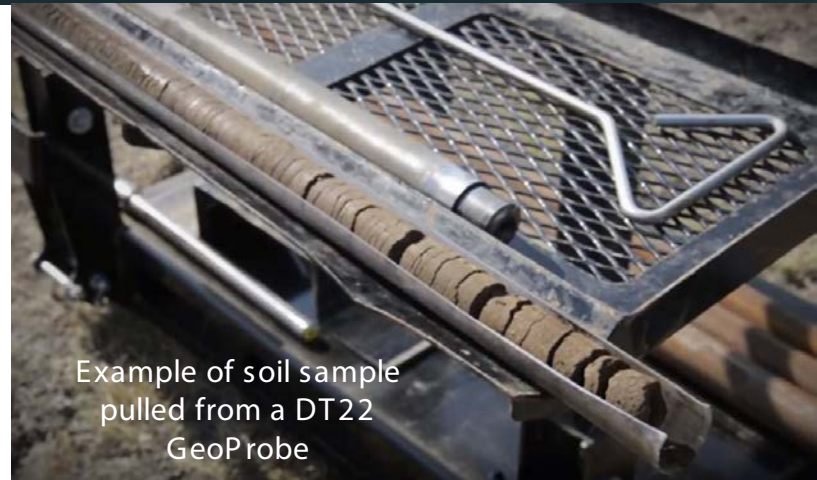
Example of soil sample
pulled from a DT22
GeoProbe

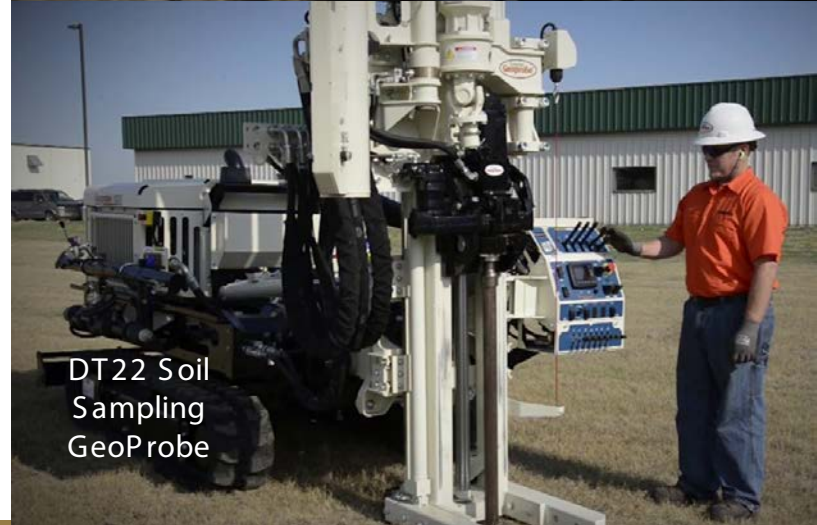
- DT22 where there's no monitoring wells
 - Continuous, unconsolidated
 - Outer casing- 2.25 in
 - Inner probe rod- 1.25 in
- DT60 where monitoring wells will be installed
 - Inner probe rod- 4 in

DT22 Soil
Sampling
GeoProbe

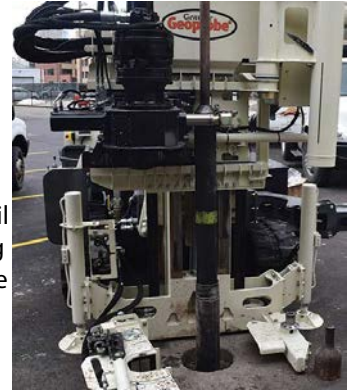
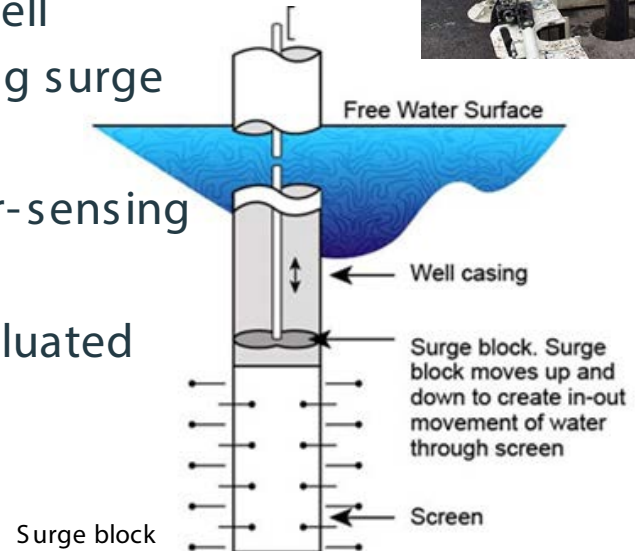
- Geoprobe DT60 soil sampling system
 - Works with soil borings to install wells
 - Expendable cutting shoe can be attached to dual tube soil sampler to install monitoring well
- Once drilling completed, well developed using surge block and pump
- Water level measured using electronic water-sensing device
 - At 2 monitoring wells, tidal changes evaluated
- Multi-parameter monitoring device

DT60 Soil
Sampling
Geoprobe
